In this issue, I'm going to document the repair of a **dbx120XP** subharmonic synthesizer. In my opinion, these units (like the Antares ATR-1) have one main flaw: the missing power switch. It means when the unit is plugged in and switched on at the socket, it's always on. It follows that some of these units will have many hours on them, regardless of what percentage of these were in actual use. In the case of this particular example, the fault presented as a totally non-functional unit. A check of the transformer revealed the secondary winding had become open circuit.

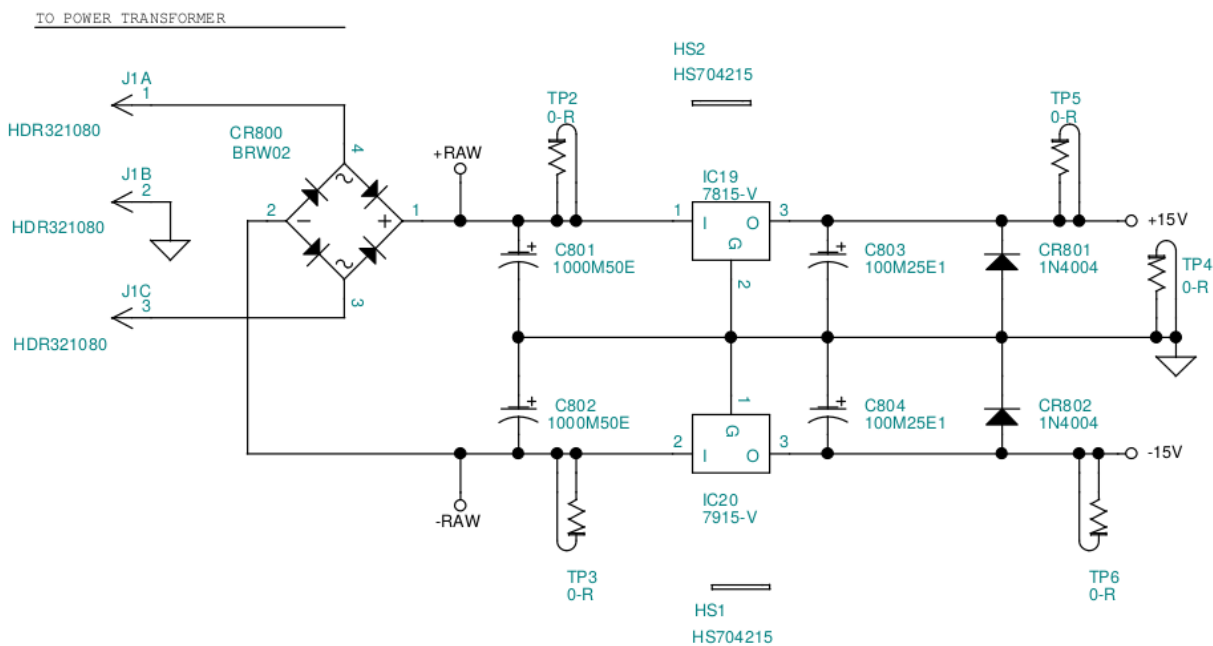
Figure 1, above: Schematic diagram showing the power input section.

The transformer is on the left side of the diagram, followed by a bridge rectifier. After this there are a pair of 1000µF capacitors, and a complimentary pair of 7815/7915 regulators for the respective +/- supplies. The layout here suggests (to me) that the unit requires a 15V +/- supply. I found a suitable transformer with a dual 15V output on the RS website (uk.rs-online.com), part number 504-773. Bridging the secondaries in series should give about 30V, from which the regulator circuit can derive the required voltages. The original transformer is shown after removal in the next picture, followed by a side-by-side comparison:

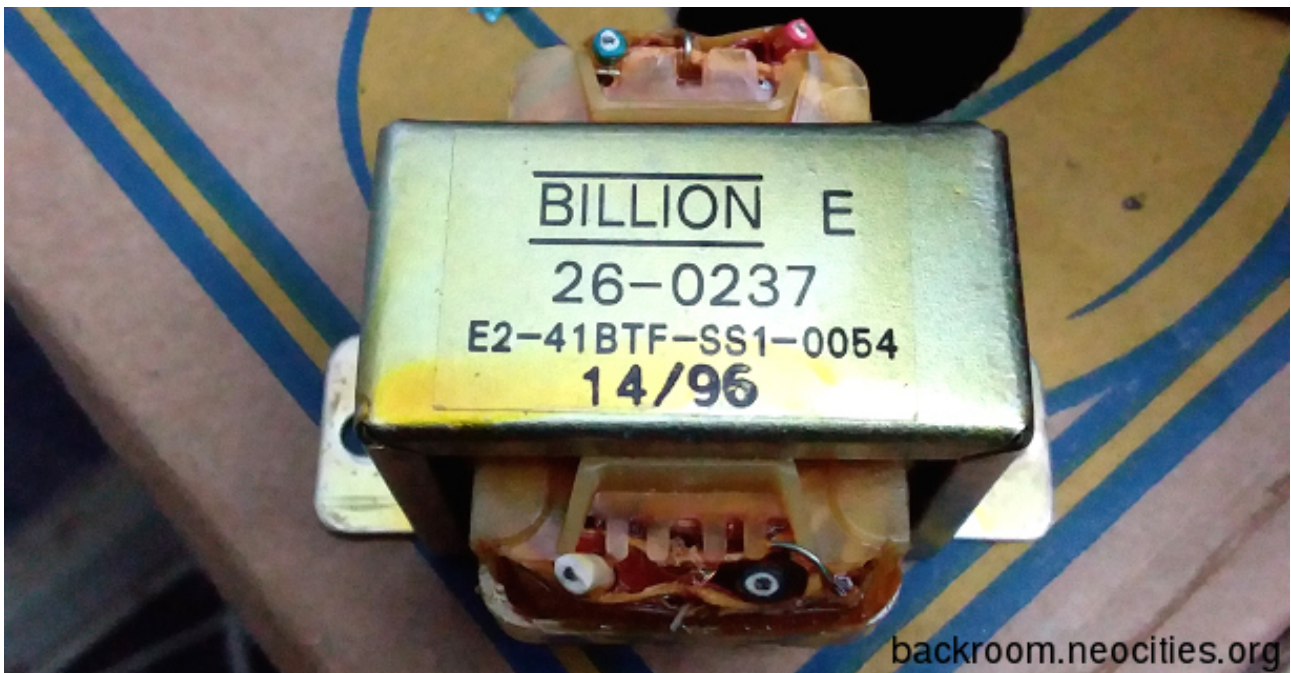
Figure two, above: *Old transformer, by Billion. A cursory internet search of this data provided no information.*

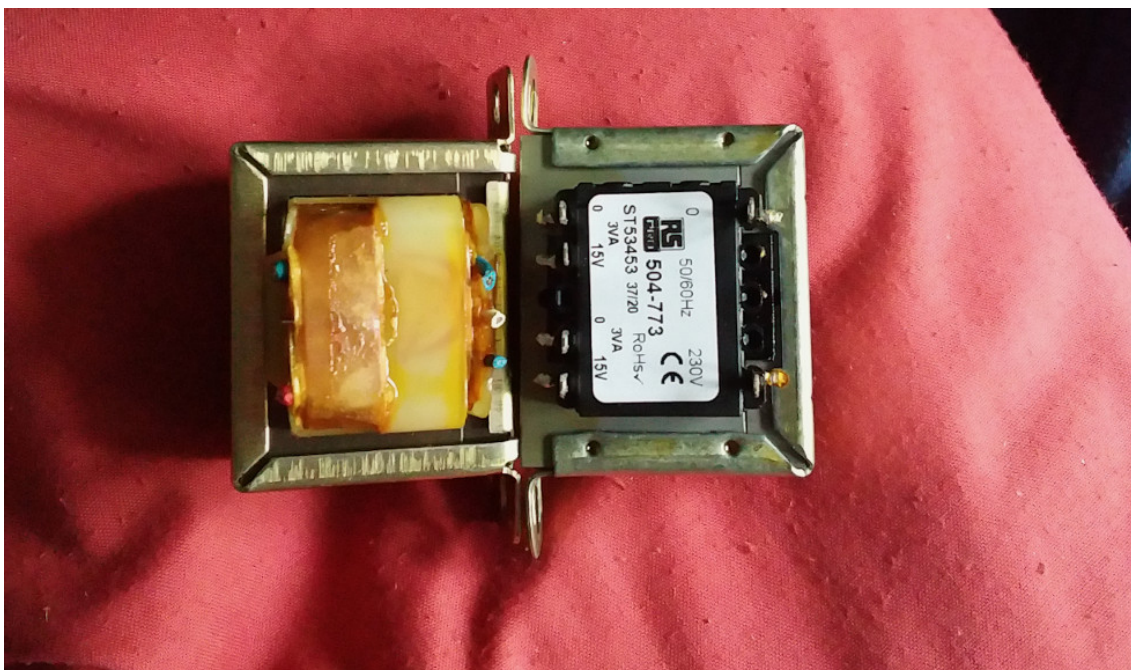
Figure three, above: *Old transformer (left) and replacement from RS Components (right).*

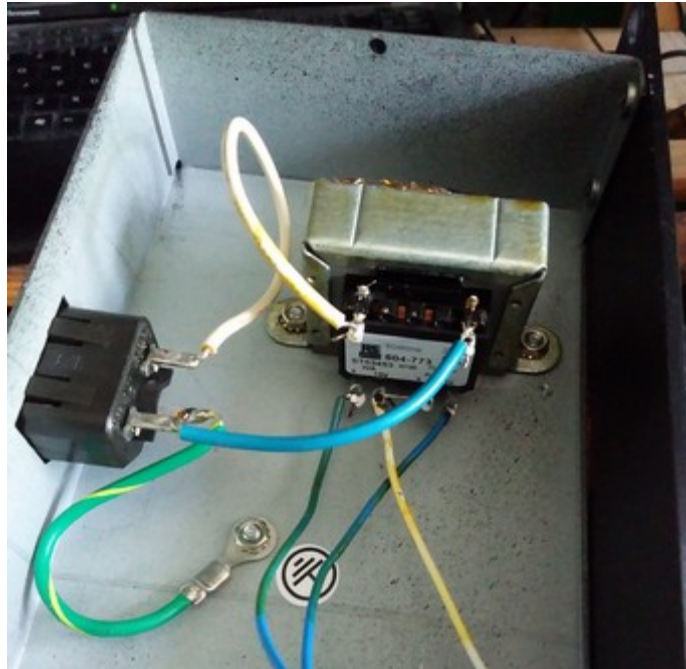
Figure four, above: Replacement transformer in situ. Wires from the secondary are: left to right: ~30V(**blue**), COMMON(**white**), ~30V(**blue**).

I used a small length of spare wire, (possibly the leg of an LED or other component) to bridge the secondary windings together in series. The replacement transformer fitted the mountings of the old one very well. I wired the internal cabling back up and replaced the case. I probably *should* have used heat shrink on the mains terminals but I didn't (I didn't have any at the time). Unless I add heat shrink, here is the last time I hope to see the transformer for 25 years or so:
