In this edition I'll detail how I repaired the headphone jack on a Roland M-DC1 sound module. The headphone jack was physically loose, and didn't work. I suspected a couple of potential faults:

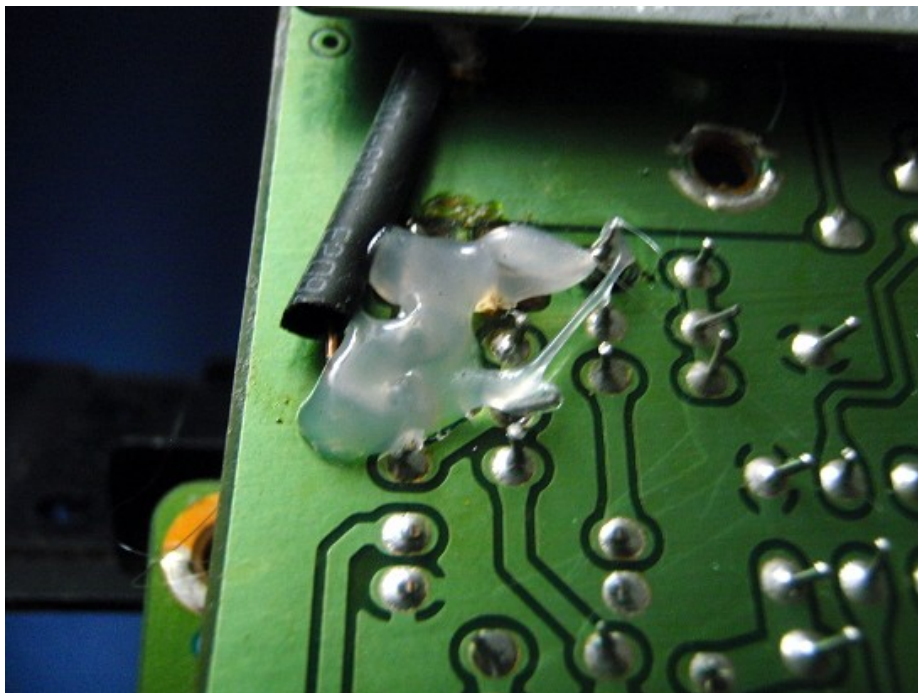
Above: *Hot melt glue thinly applied to the PCB and new tracks.*

I decided there was a risk the large L/R PCB track pads may bridge the surrounding gaps, so I removed these completely. I then remade the paths using thin, solid core copper wire to bridge the jack connections with their previously connected component on the board. Finally, I applied a thin layer of hot melt glue in order to provide some additional physical security to the legs of these components and the new track repairs. First the PCB-side:

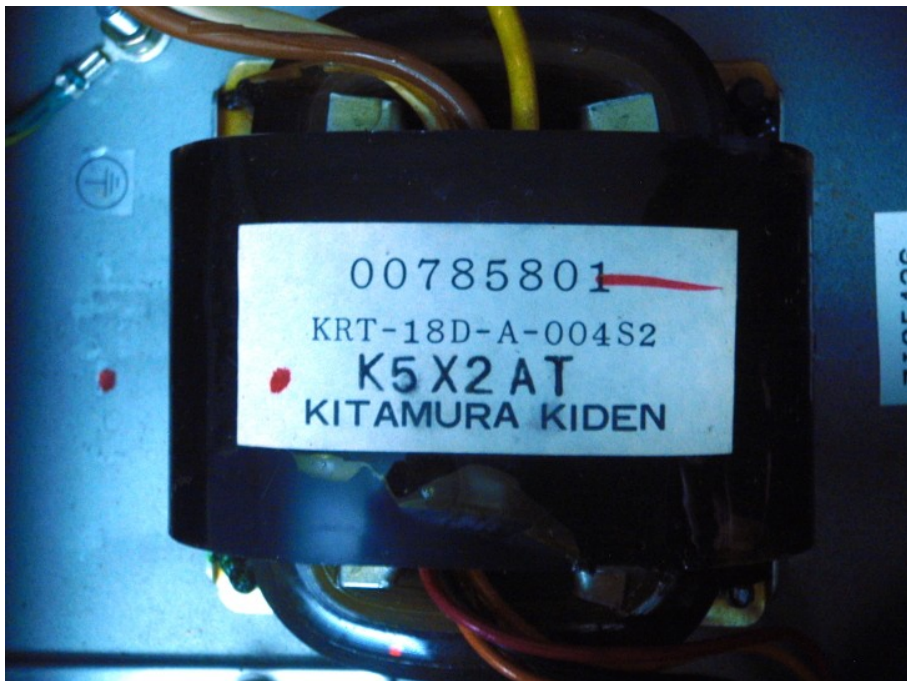
Finally, as it can be difficult to find suitable replacement transformers for 1U equipment, I've included a picture of the transformer in this unit for future reference. The markings are "00785801 KRT-18D-A-004S2 K5X2AT KITAMURA KIDEN". The transformer is shown below:

Above: *Transformer, showing markings for future reference.*
